Manhole Inspection Summary

Manhole # S45UU_021MH

Insp Date: **2/8/07 9:43 AM**

Location Address: **2746 TIVOLY AVE**

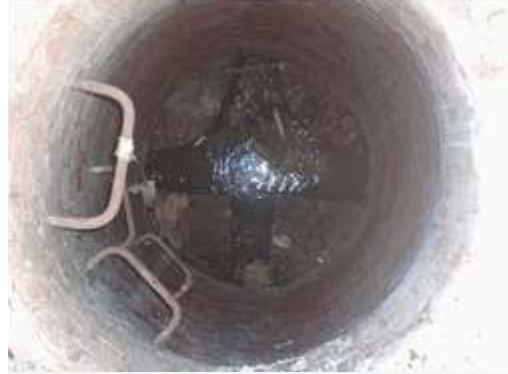
Top View

Barrel infiltration. Evidence of surcharge - Bench debris. Channel debris.

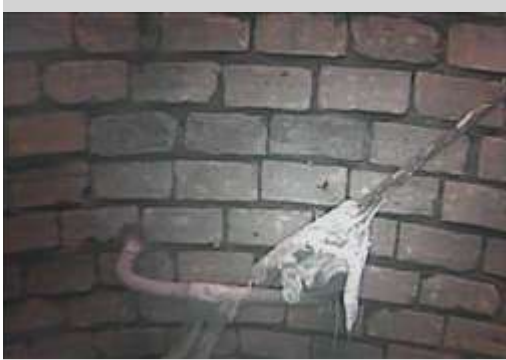
Defect

Evidence of surcharge.

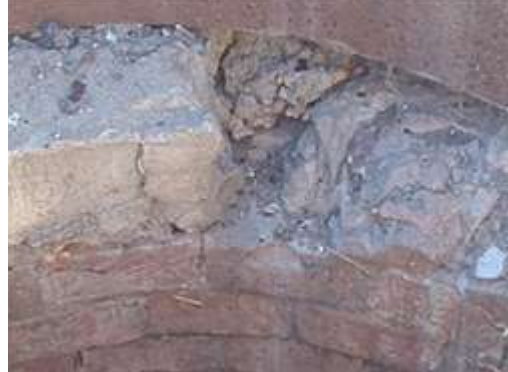
Defect

Frame leaks. Frame offset. Adjustment deterioration and infiltration.

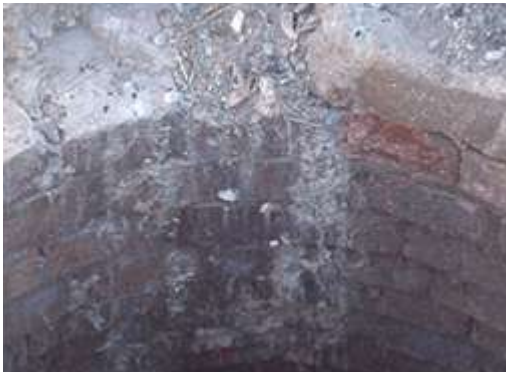
Defect

Frame leaks. Frame offset. Adjustment deterioration and infiltration.

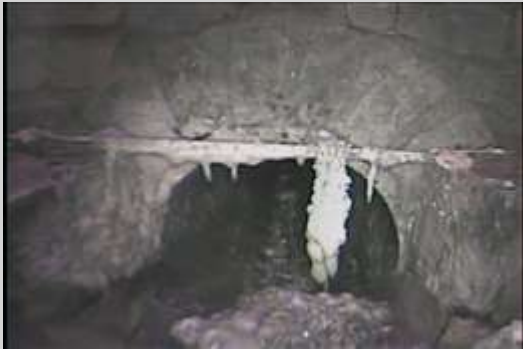
10 in. Circular Gravity Sewer Pipe Out @ 12 O'Clock

Deposits: ☐ None ☐ Mud ☐ Sludge ☒ **Debris** ☐ **Grease**

Silt Depth: **0** (in.) Deposits Extent: **Light**

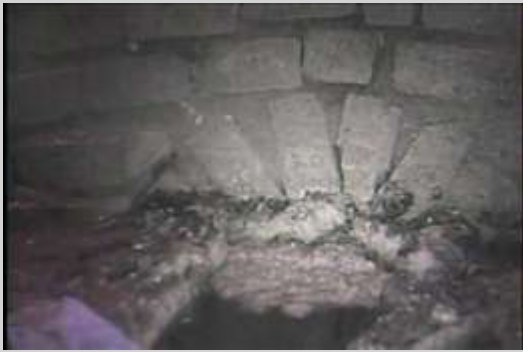
8 in. Circular Gravity Sewer

Deposits: ☐ None ☐ **Mud** ☐ Sludge ☐ Debris ☒ **Grease**

Silt Depth: **4** (in.) Deposits Extent: **Heavy**
